Manhole Inspection Summary

Manhole # S31E__015MH

Insp Date: **8/11/08 8:31 AM**

Location Address: **500 w fayette st**

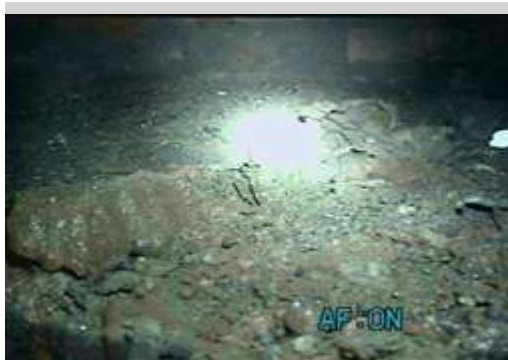
Defect 4

Condition: ☐ Sound ☐ Cracked ☐ Root Intrusion ☐ Deteriorated ☐ Leaks ☒ **Debris**

channel debris

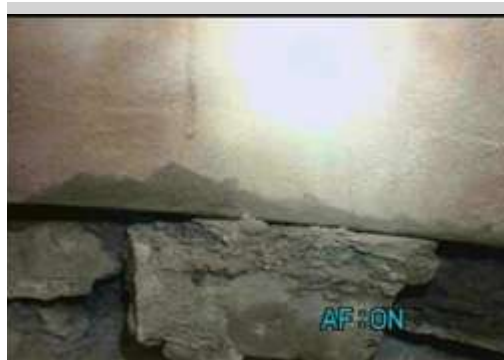
Defect 3

Condition: ☐ Sound ☐ Cracked ☐ Root Intrusion ☒ **Loose Brick** ☐ Deteriorated

chimney cond loose bricks

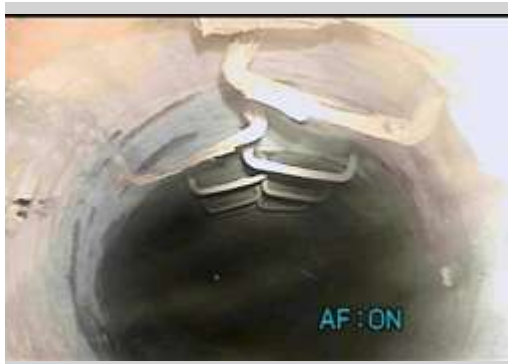
Defect 2

Count: **8** Missing: **0** ☒ **Corroded**

steps

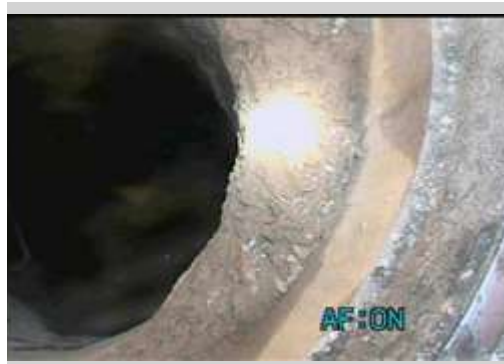
Defect 1

Offset: **3** (in.)

offset

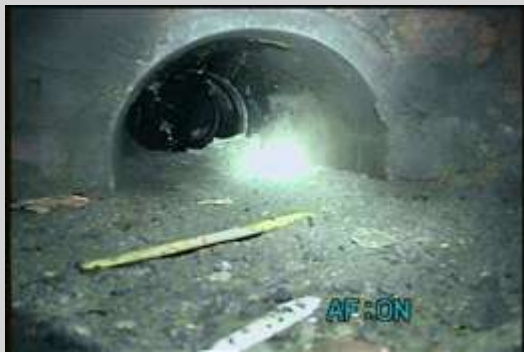
12 O'Clock Outflow

Deposits: ☐ None ☐ Mud ☐ Sludge ☒ **Debris** ☐ Grease

Silt Depth: 0 (in.) Deposits Extent: **Medium**
